INJECTORS, O-RINGS AND STRANGE LEAKS.

Background.

The 4JX1 diesel engine was one of the first of the modern high performance diesel engines delivering previously unknown levels of torque and power. The engine was manufactured by Isuzu in Japan and fitted to their range of 4WD vehicles sold around the world in the period 1998 – 2004, or thereabouts. This vehicle was sold in Australia under the Holden brand as the Jackaroo 3.0 TDI.

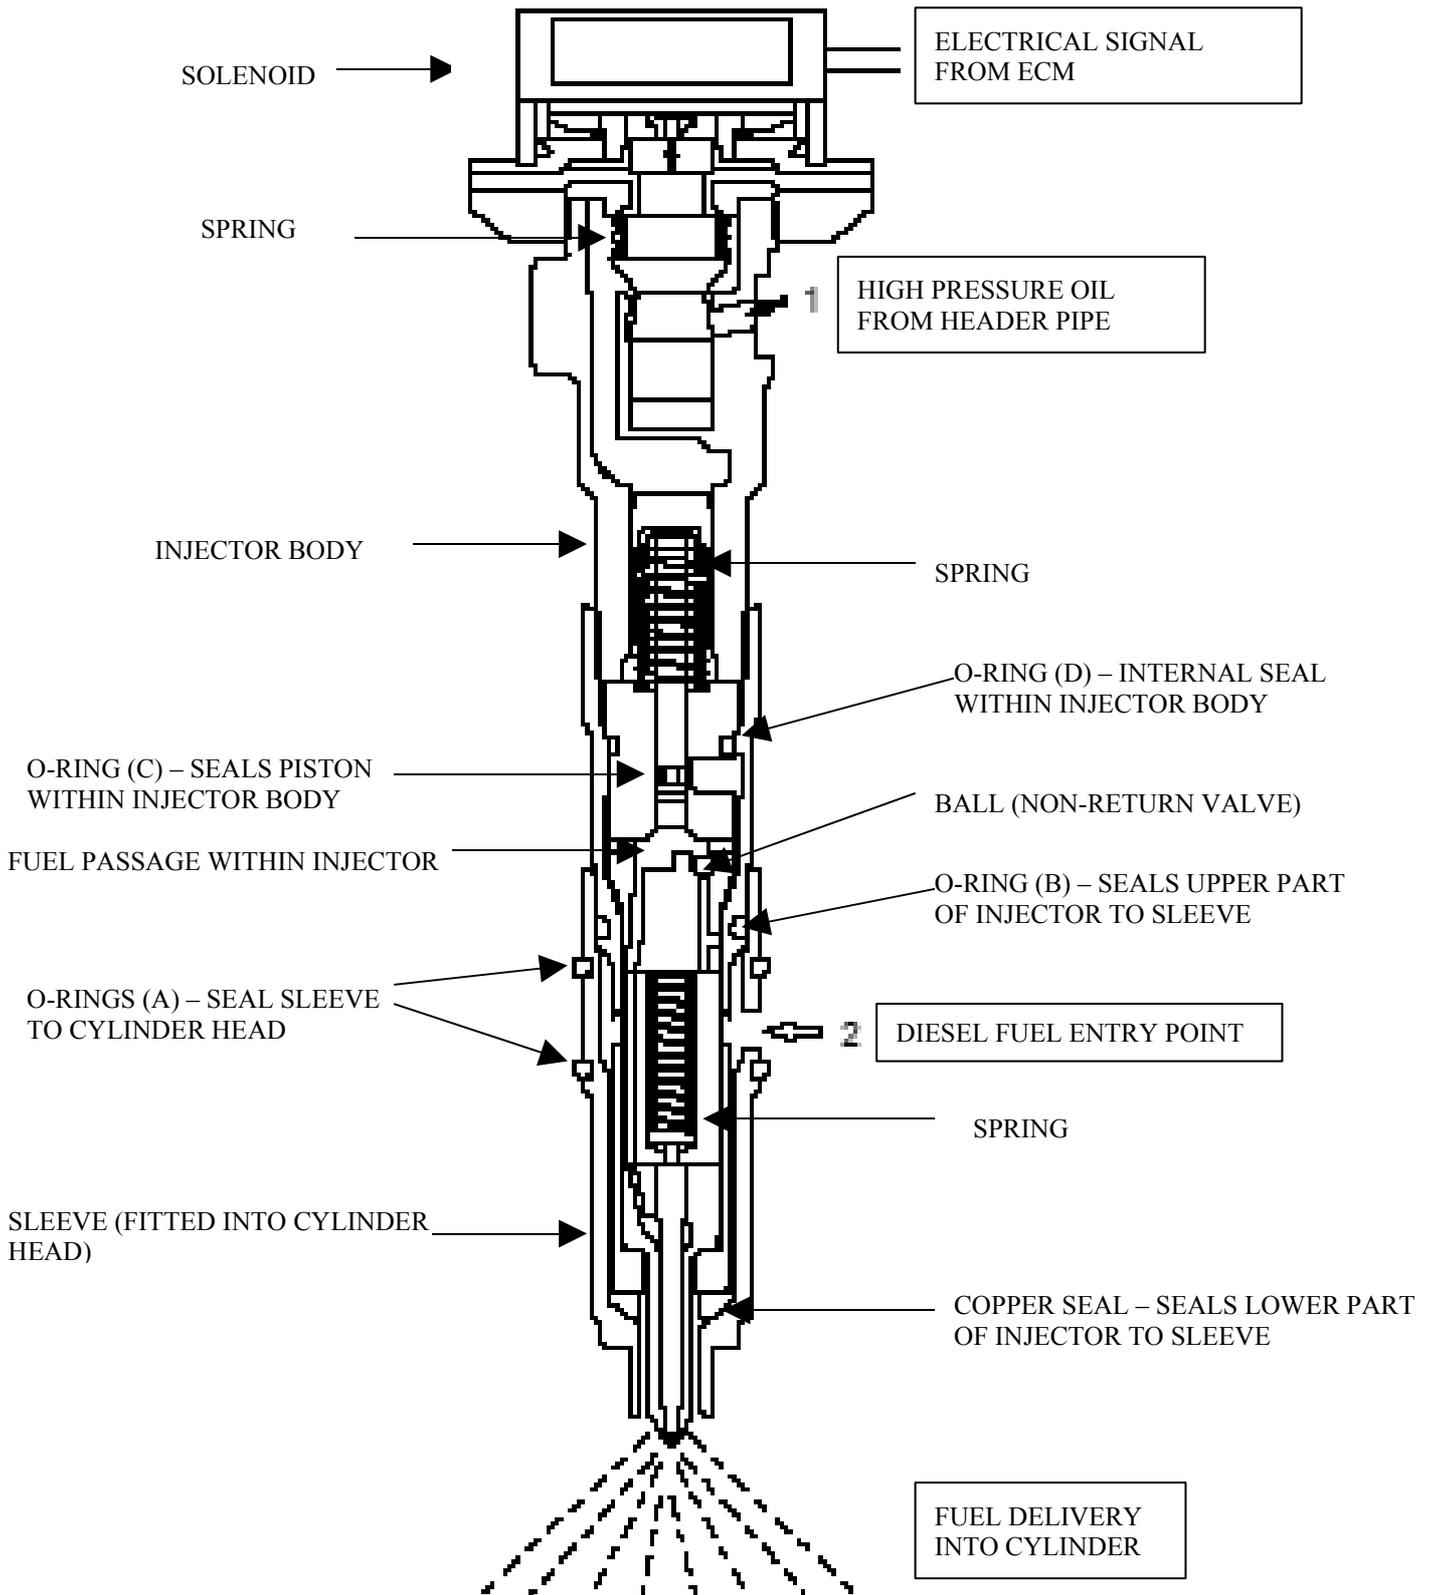
Refer ring to Diagram 1, the most common O-ring failures appears to involve those at Locations A and B - fortunately these can be replaced fairly easily. Failure of the O-rings at Locations C and D are more serious because they require replacement of the injectors themselves, which is a costly business. Of these, the O-ring at Location C appears much more likely to fail due to it’s hostile operating environment.

O-Ring Location (See Diagrams)	Fluids Sealed	Symptoms	Note
Location A - between sleeve and cylinder head	- diesel fuel - engine cooling water	- diesel leaks into coolant - coolant overflows - smell of diesel in coolant	Easiest O-rings to change.
Location B - between injector and sleeve	- diesel fuel - engine lubricating oil (drains back to sump)	- diesel leaks into sump - sump level rises - oil may leak from shaft seal - oil overflows into crankcase breather - engine may run on own oil - possible runaway engine	
Location C - within injector body. Dynamic seal on piston.	- diesel fuel - injector oil (drains back to sump)	- diesel leaks into sump - sump level rises - oil may leak from shaft seal - oil reaches crankcase breather pipe	Not commercially viable to replace O-rings inside injectors. New injectors are very expensive.
Location D - within injector body	- diesel fuel - engine lubricating oil (drains back to sump)	- oil sucked into engine intake - engine may run on own oil - possible runaway engine

DIAGRAM 1 - CUT-AWAY SECTION OF INJECTOR SHOWING LOCATION OF O-RINGS

- At each 80 k kms service interval, replace the O-rings between injectors and sleeves, and between sleeves and cylinder head, as a precaution. This will add little to the

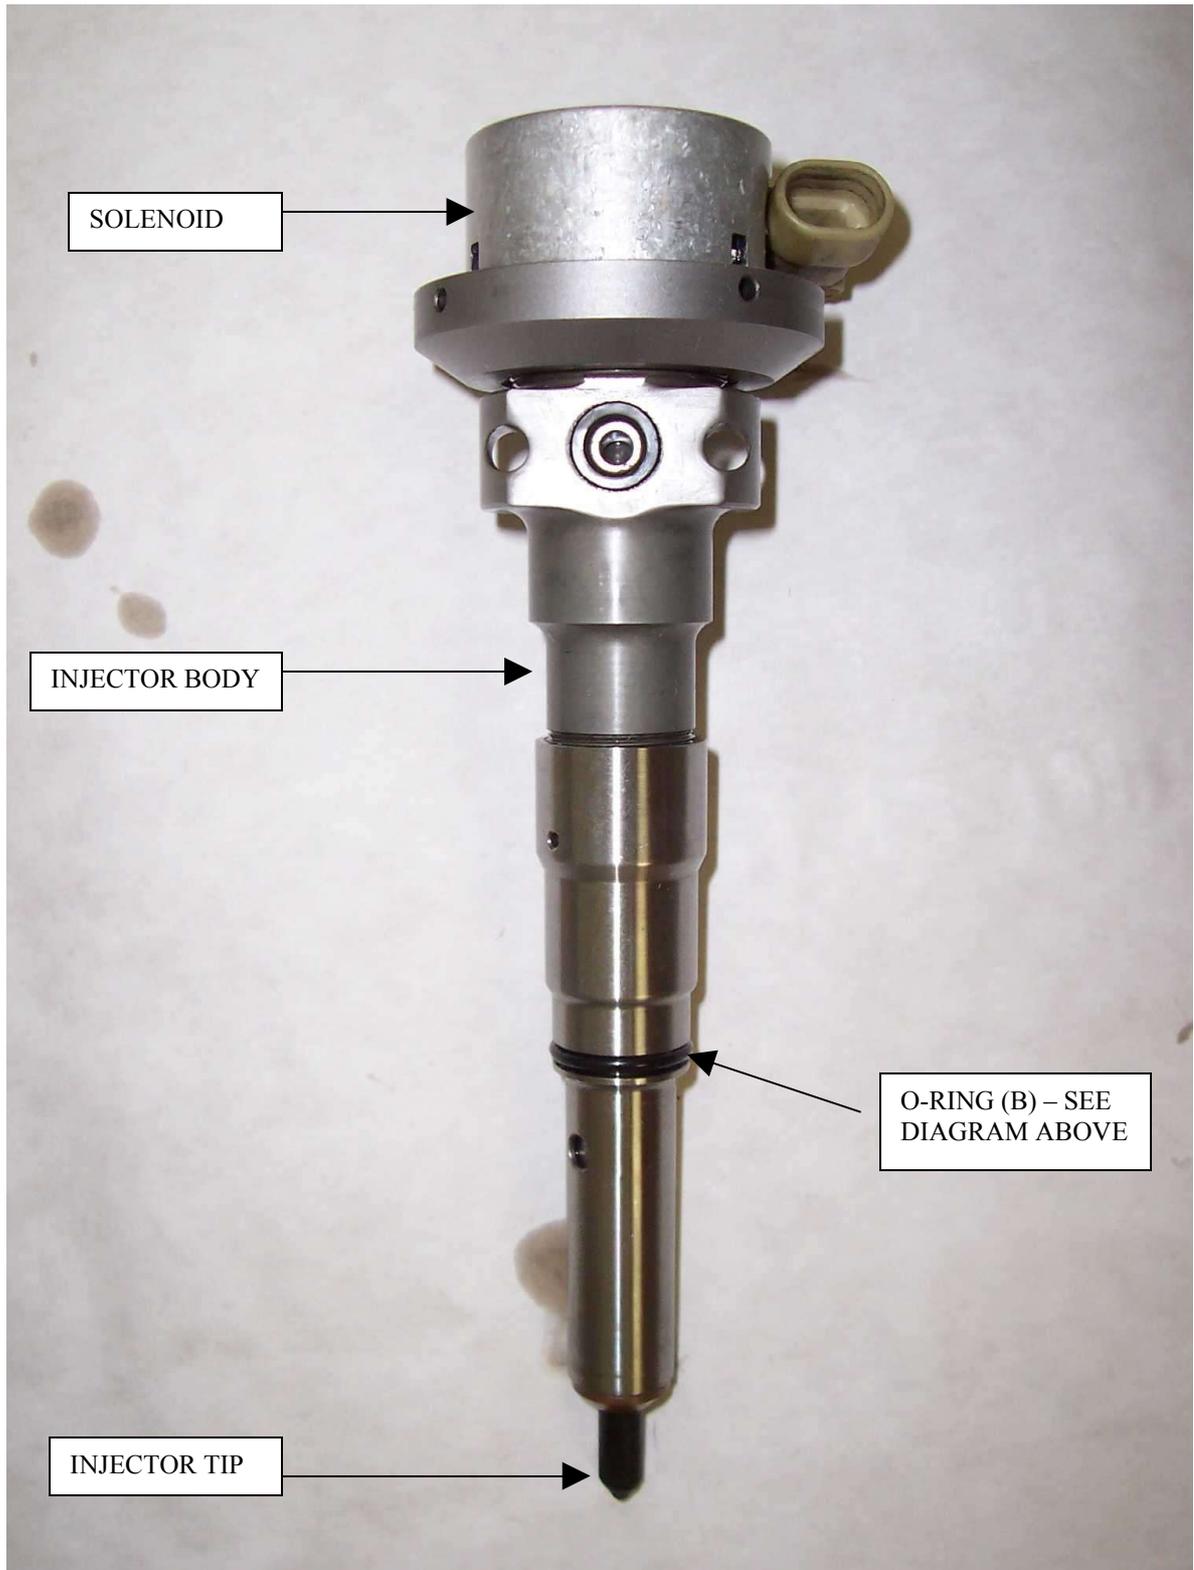
Diagrams 1 and 2 show the overall injector assembly. Each injector was carefully dismantled, and the component parts cleaned and visually inspected. Refer Diagrams 3 and 4 for dismantled parts. The overall condition of each injector appeared to be very good, with very little sign of wear on any of the metal parts. By contrast, the small, green coloured O-ring at the heart of each injector had suffered very serious deterioration. Refer Diagrams 5 and 6 for typical condition of these O-rings. During operation, this had obviously allowed the pressurised diesel to leak within the injector body and escape into the oil return to sump, and so cause the sump oil level to rise.

DIAGRAM 2 - INJECTOR AS REMOVED FROM ENGINE, PRIOR TO DISMANTLING

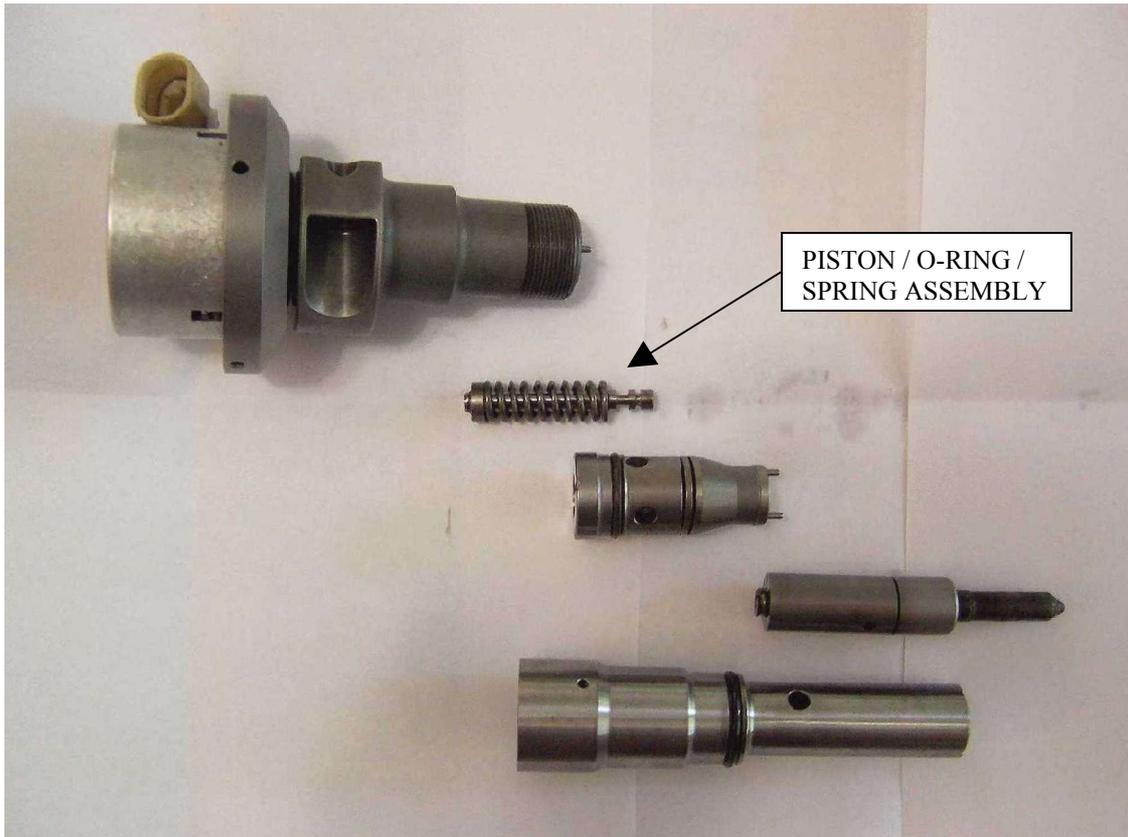
DIAGRAM 3 - INJECTOR DISMANTLED INTO COMPONENT PARTS

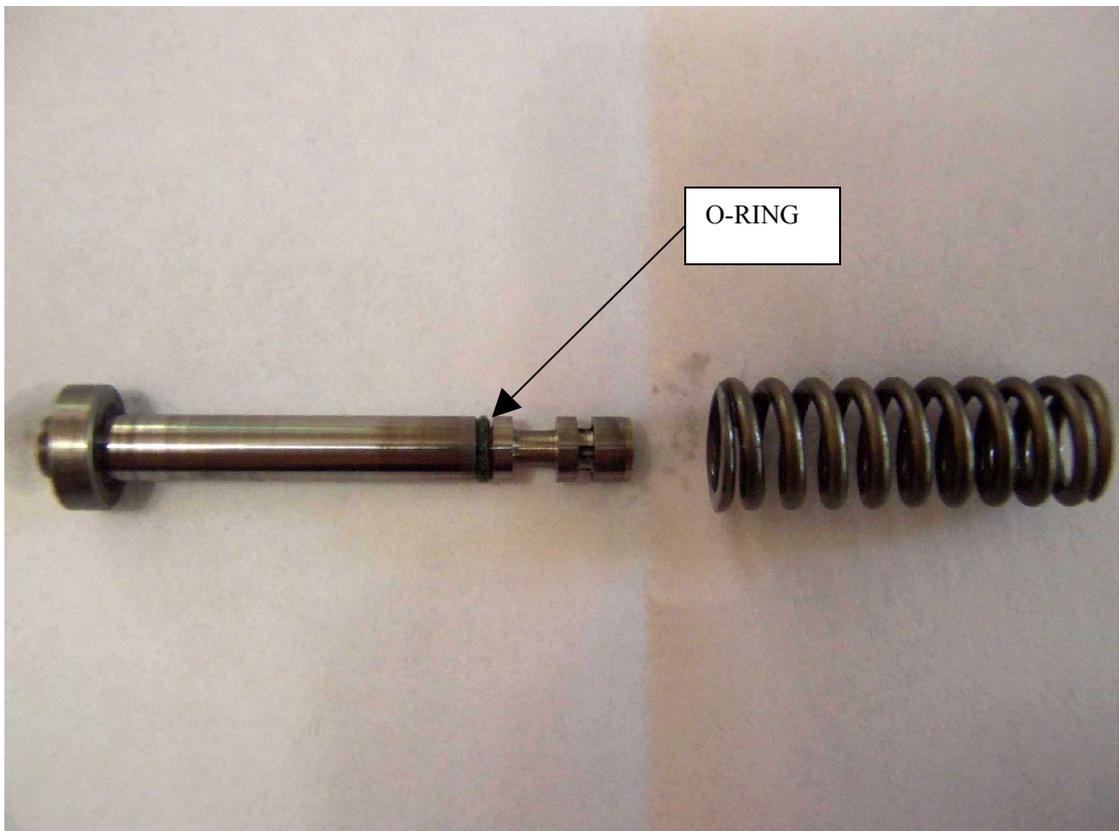
DIAGRAM 4 - PISTON / O-RING / SPRING (REMOVED FROM INJECTOR BODY)

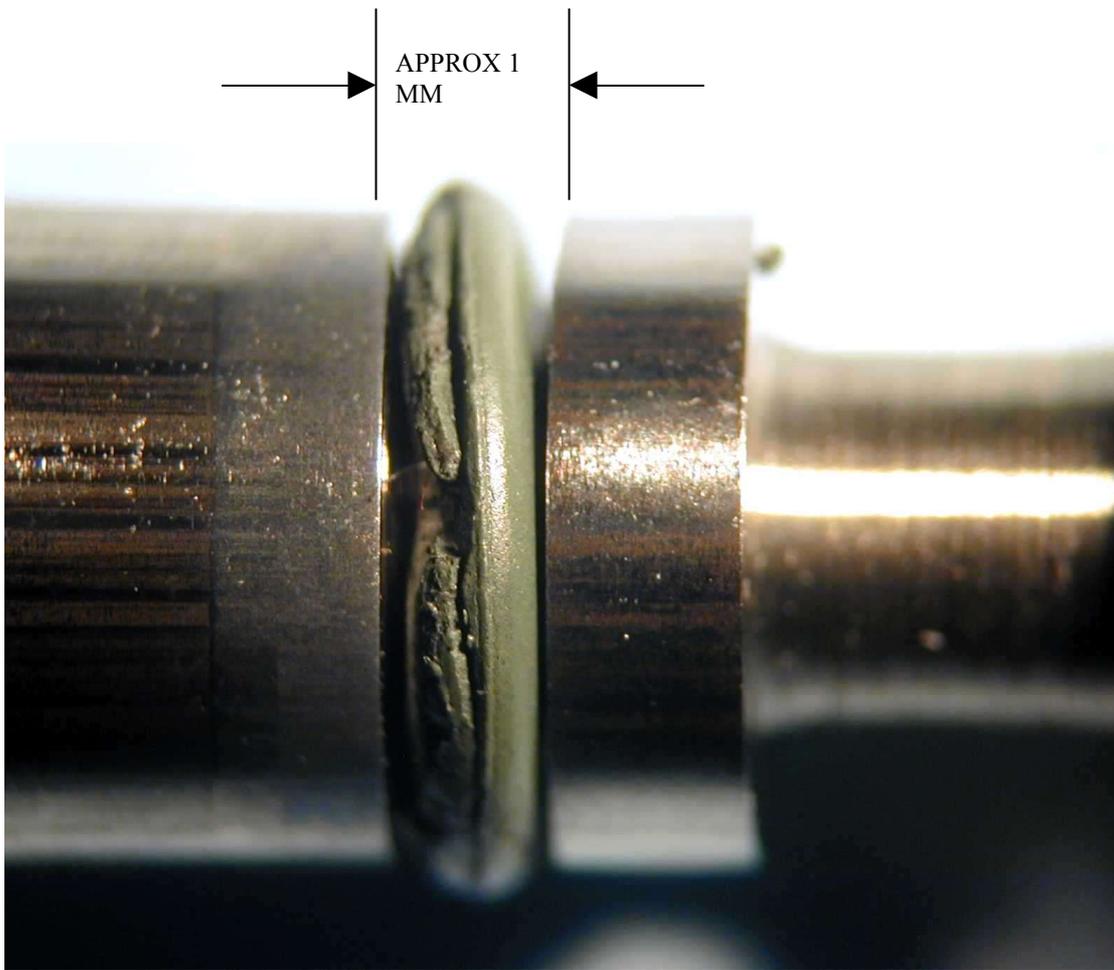
DIAGRAM 5 - HIGH MAGNIFICATION PHOTO SHOWING O-RING IN GROOVE ON PISTON

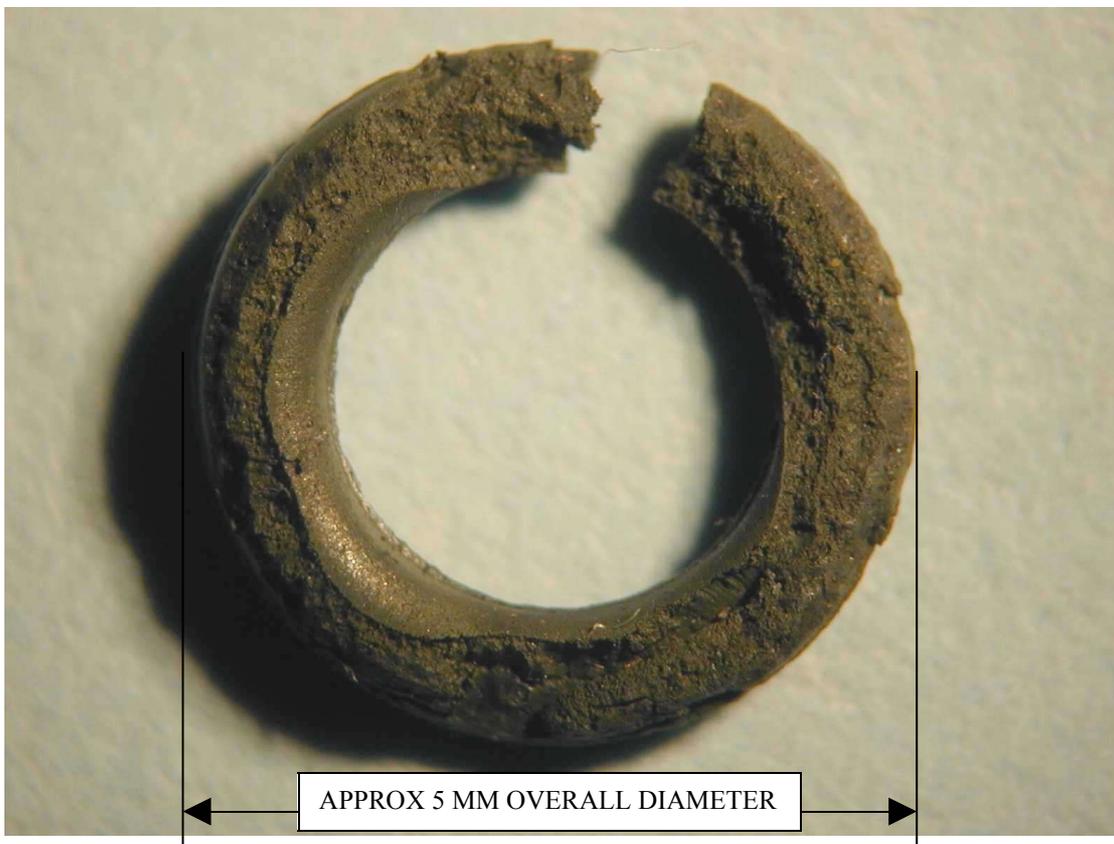
All these O-rings, except for those fitted to the pistons inside the injectors (C above), form a static seal between stationary parts. In contrast, the failed O-rings (C above) are subject

to very rapid, reciprocating dynamic forces as the injector piston moves up and down as a normal part of engine operation.

DIAGRAM 6 - HIGH MAGNIFICATION PHOTO SHOWING MASSIVE DETERIORATION OF O-RING

Early injectors (up to Serial No. 519266) used a rubber O-ring material (green colour probably Viton) but later ones were fitted with ceramic seals instead. Whenever owners are having injectors replaced, they should ensure only later model injectors (ie after 519266) are fitted, as these will have the most recent ceramic seals.

However, in practice, it is technically possible to replace the O-rings and reassemble the injector providing great care is taken. If the injector is in otherwise satisfactory condition, and the internal O-rings are replaced with the correct size and equivalent or better material, I believe this will have very little effect on the injector grading. This may be an option for owners of higher mileage vehicles, faced with the alternative high cost of new injectors.
