TECHNICAL SERVICE BULLETIN No.LTB00300/2010

08 July 2010

Subject/Concern:	Non-Start Temperature Gauge In The Red				
Model:					
Defender (LD) - 2.4L Puma Diesel Only	VIN Range: 7A732615-AA790554				
Markets:	All except NAS				
Section:	303-00

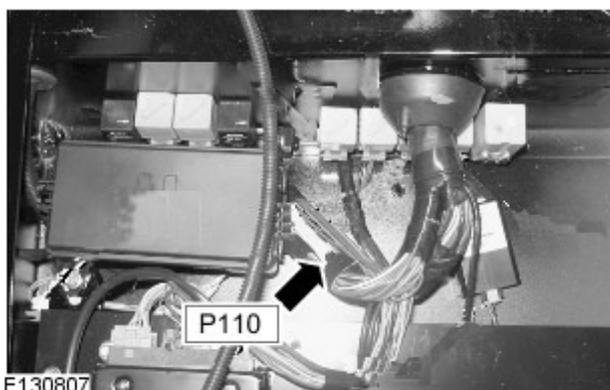
1. Fuse P110 is secured to the harness (see graphic E130807).

Check continuity of inline fuse P110 fuse, located under the RH front seat (see graphic E130807). If the fuse has failed, replace as necessary and check related wiring circuit for any signs of a potential cause, paying particular attention to the harness route around the red colored engine lifting eye at rear of engine and the area around the exhaust gas re-circulation valve for signs of abrasion, rectify as necessary.

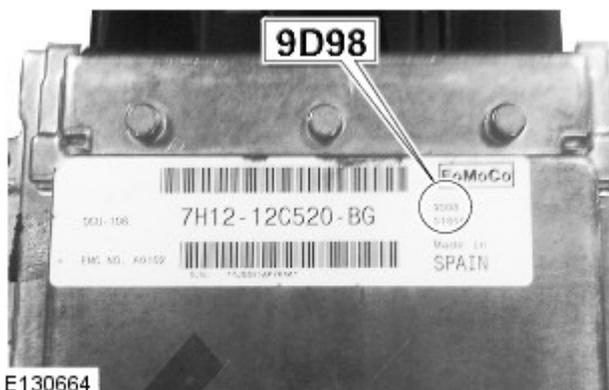
5. For PCM date code reference see examples below.

Remove the engine cover, reference GTR 501-05 interior trim, using a mirror to read the 4/5 digit number on the top right corner of the PCM. Note the batch code reference number and identify the build date of the PCM (see graphic E130664). If the build date is earlier than 14th October 2009, replace the powertrain control module reference GTR 303-00 and continue to step 7.

1. Year 8 = 2008/9 = **2009**/0 = 2010.

2. Month C = March/ **D = April**/ F = June.

3. 044 = Day 44/ **98 = Day 98**/304 = Day 304.

6. If the build date is the 14th October 2009 onwards, there is no need to replace the PCM. Refit the engine cover and clear the fault codes and re-assess the vehicle for the concern, if the concern does not re-appear return vehicle to the customer. If the concern re-appears continue with diagnosis with reference to GTR and SDD.
