TECHNICAL SERVICE BULLETIN

reissue No.LD310-001/2004
29 October 2004

Subject/Concern:	Defender Td5 Poor Starting/Noisy Fuel Pump
Model:	
Defender (LD)	VIN Range: 4A 659872-4A 661642

Markets: All
Section: 310-01 (Fuel Delivery System - 19)

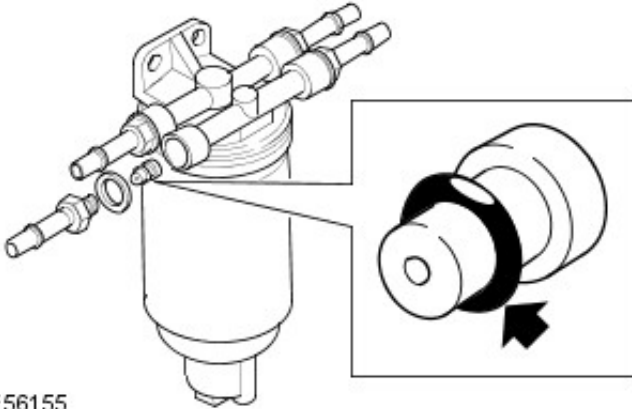
E56155

Cause: The O-ring seal on the fuel filter air bleed valve may be split, allowing air into the fuel system (If air is being introduced into the fuel system, it will make the primary fuel pump sound noisy).

- Withdraw the air bleed valve from inside the brass fitting. Inspect the O-ring and plastic body for splits and damage.

- If the O-ring is damaged, renew parts provided in the service repair kit.
- Prime the fuel system using the ignition cycling procedure described in the Owner's Handbook (Driving and Operating / Fuel Filling / Empty Fuel Tank).
- Run the engine for 10 minutes to purge all air from the fuel system.
